SECTION 32 PROGRAM
STREAMBANK EROSION CONTROL
EVALUATION AND DEMONSTRATION
WORK UNIT 4-RESEARCH ON SOIL STABILITY AND
IDENTIFICATION OF CAUSES OF STREAMBANK EROSION

INVESTIGATION OF A GRID FOR
BANK PROTECTION

November 1979
Investigation Report 3

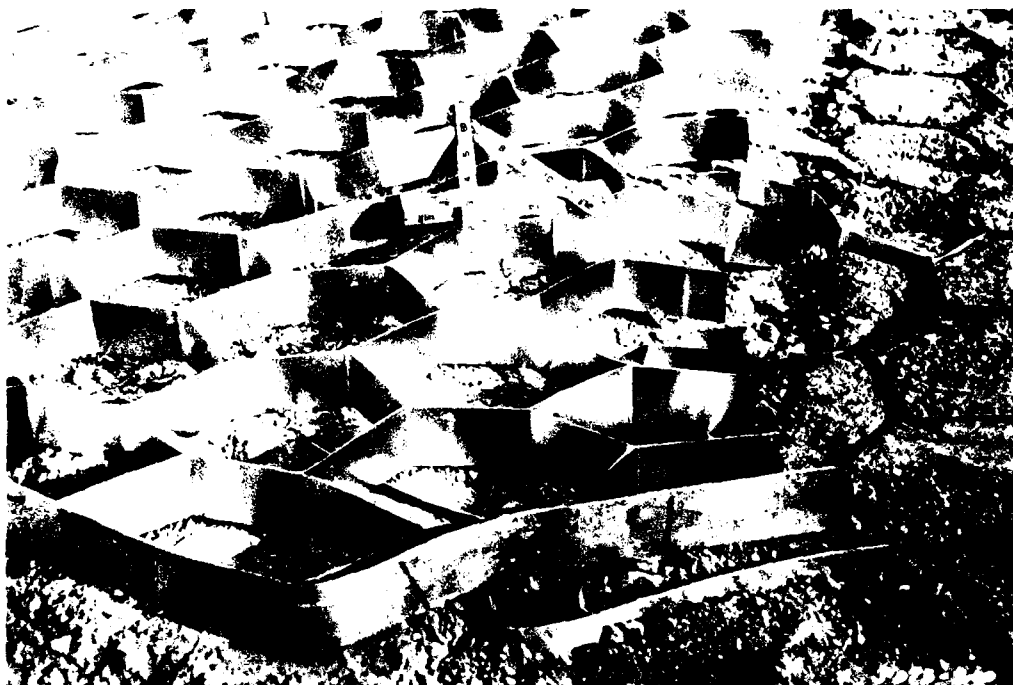
Photo 1. Aluminum grid with 6-in.- (15.24-cm-) wide hexagonal cells that are 2 in. (5.08 cm) deep

3. An aluminum grid system made in a honeycomb design was used in the test. Each section was fabricated from 0.014-in.- (0.36-mm-) thick 300J-H14 aluminum alloy sheets, formed by bonding into a structure with 6-in.- (15.24-cm-) wide hexagonal cells that are 2 in. (5.08 cm) deep (Photo 1). The size of a section prior to expansion was 1-5/16 in. by 10 ft 1-1/2 in. (3.33 cm by 3.09 m) (Photo 2) and after expansion was 20 by 8 ft (6.10 by 2.44 m) (Photo 3). Each section had a total weight of 27-1/2 lb (12.47 kg) or 0.17 lb per sq ft (0.83 kg/m²). Two of these aluminum grid sections were used. This test material costs about \$0.70 per sq ft.

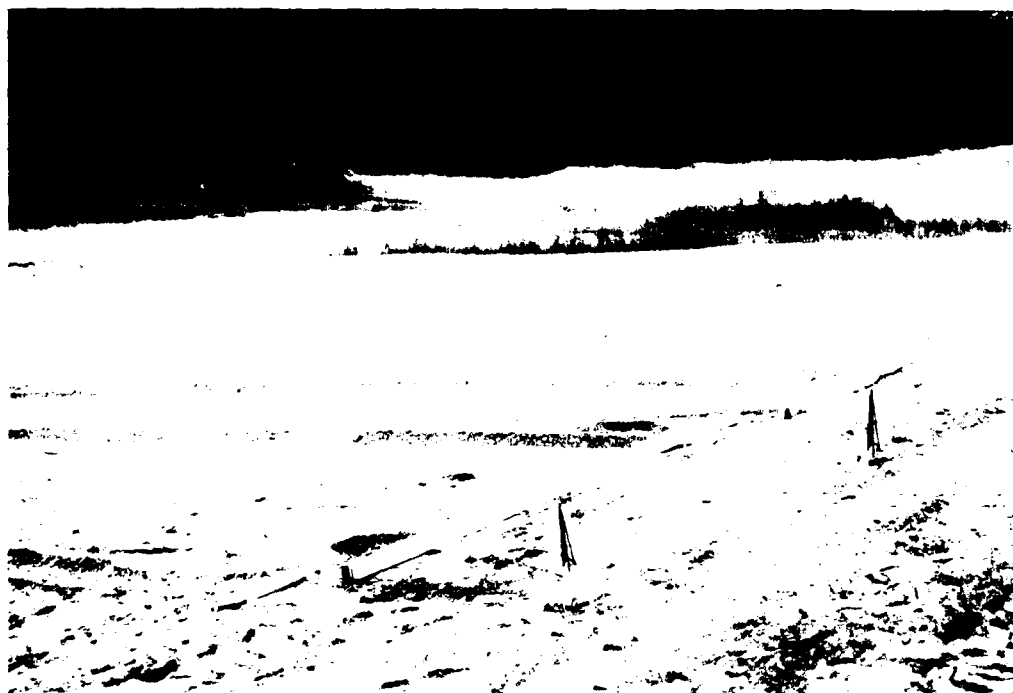
Photo 2. Aluminum grid sections as received from manufacturer (prior to expanding and placing grids on test site)

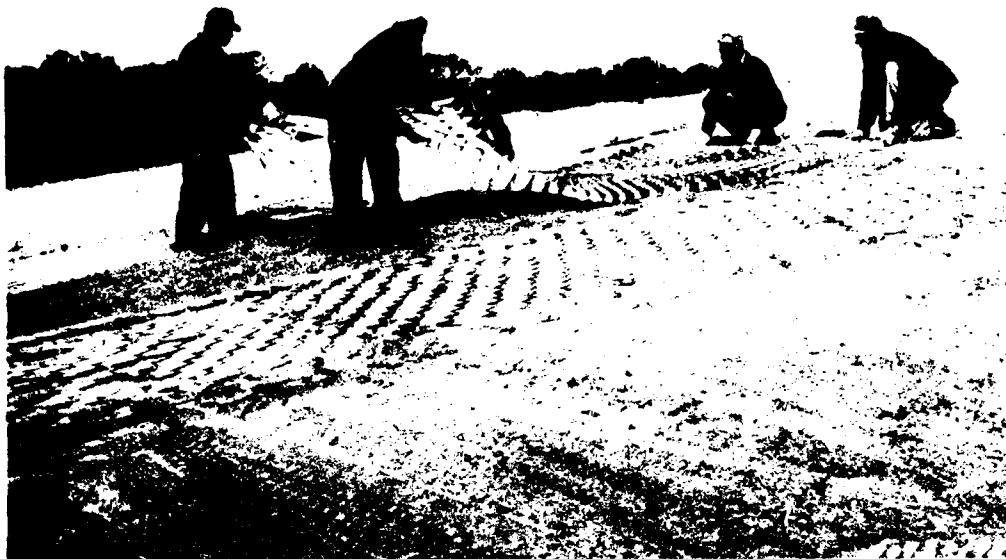
Photo 3. Grid being placed by hand

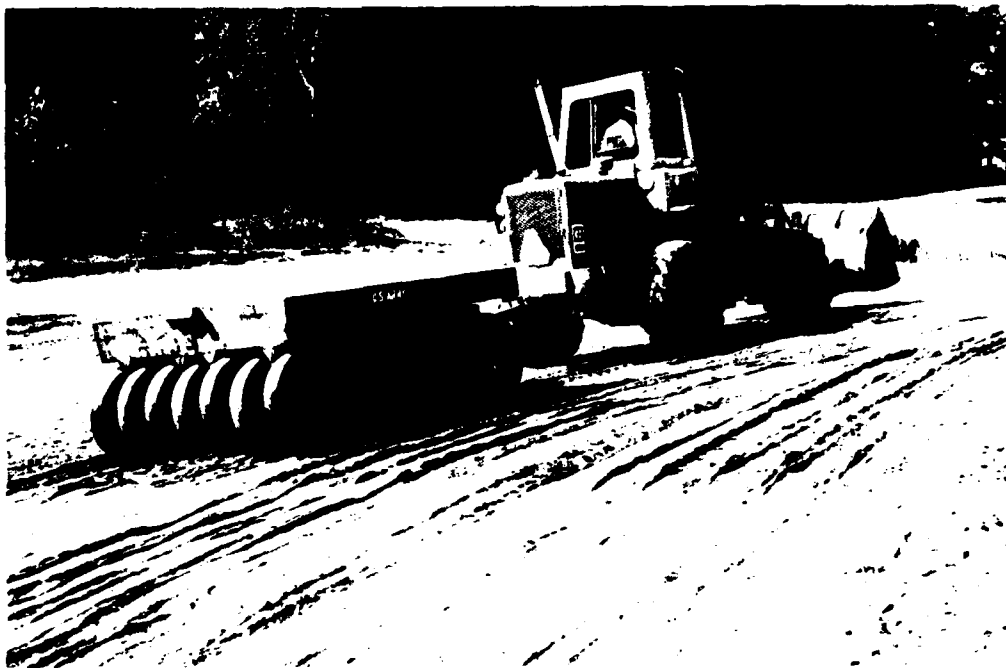
Photo 7. Rubber wheel roller used for compaction purposes

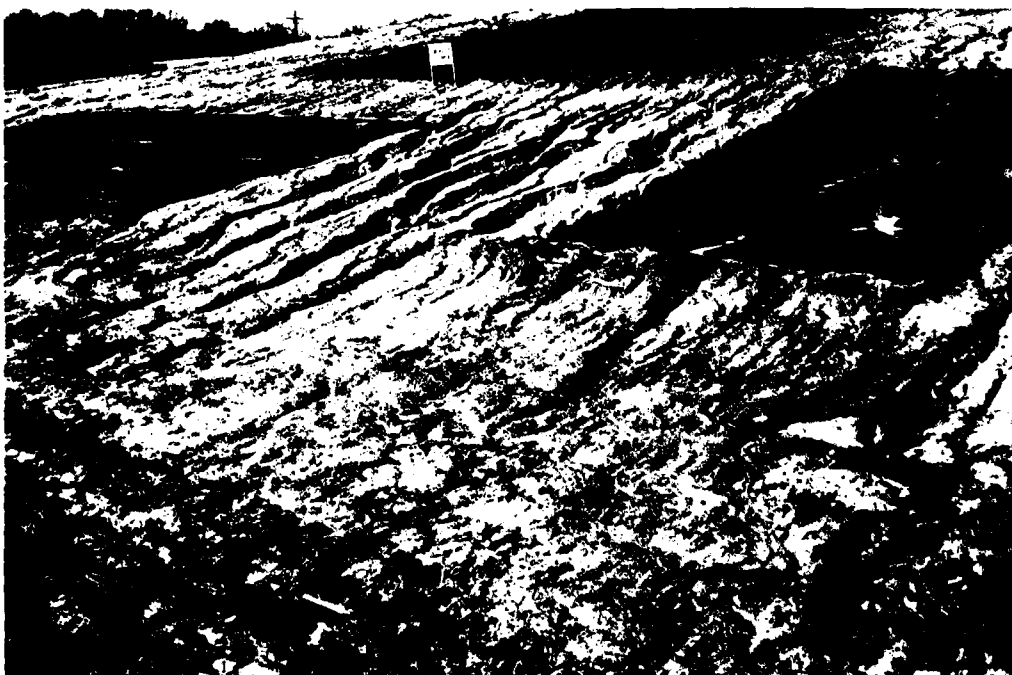
Photo 10. Severe erosion in unprotected, unseeded area adjacent to test area (covered areas below and to the right of the test area will be discussed in a subsequent report(s))

because of the concentrated overland flow of water, a rill 3 to 5 in. (7.62 to 12.70 cm) had formed (Photo 8). The grid section that had a good grass growth started experienced no erosion (Photo 9). The area adjacent to the test section had severe erosion in the unprotected, unseeded area (Photo 10). Observations continued for six months, 1 October - 31 March. One rill protected by rye grass (only) is shown to progress from 3 to 5 in. (7.62 to 12.70 cm) on 5 December (Photo 8) to 8 to 12 in. (20.32 to 30.48 cm) on 12 March (Photo 11). After six months, the area within the grid showed very little or no erosion (Photo 12). Figure 2 presents the amount of monthly precipitation as a bar graph, and Figure 3 shows daily high and low temperatures.
